COMPOSITE JOIST PROJECT

SPONSORED BY STEEL JOIST INSTITUTE

INTERPRETATION OF COMPOSITE JOIST TEST RESULTS

September 1967

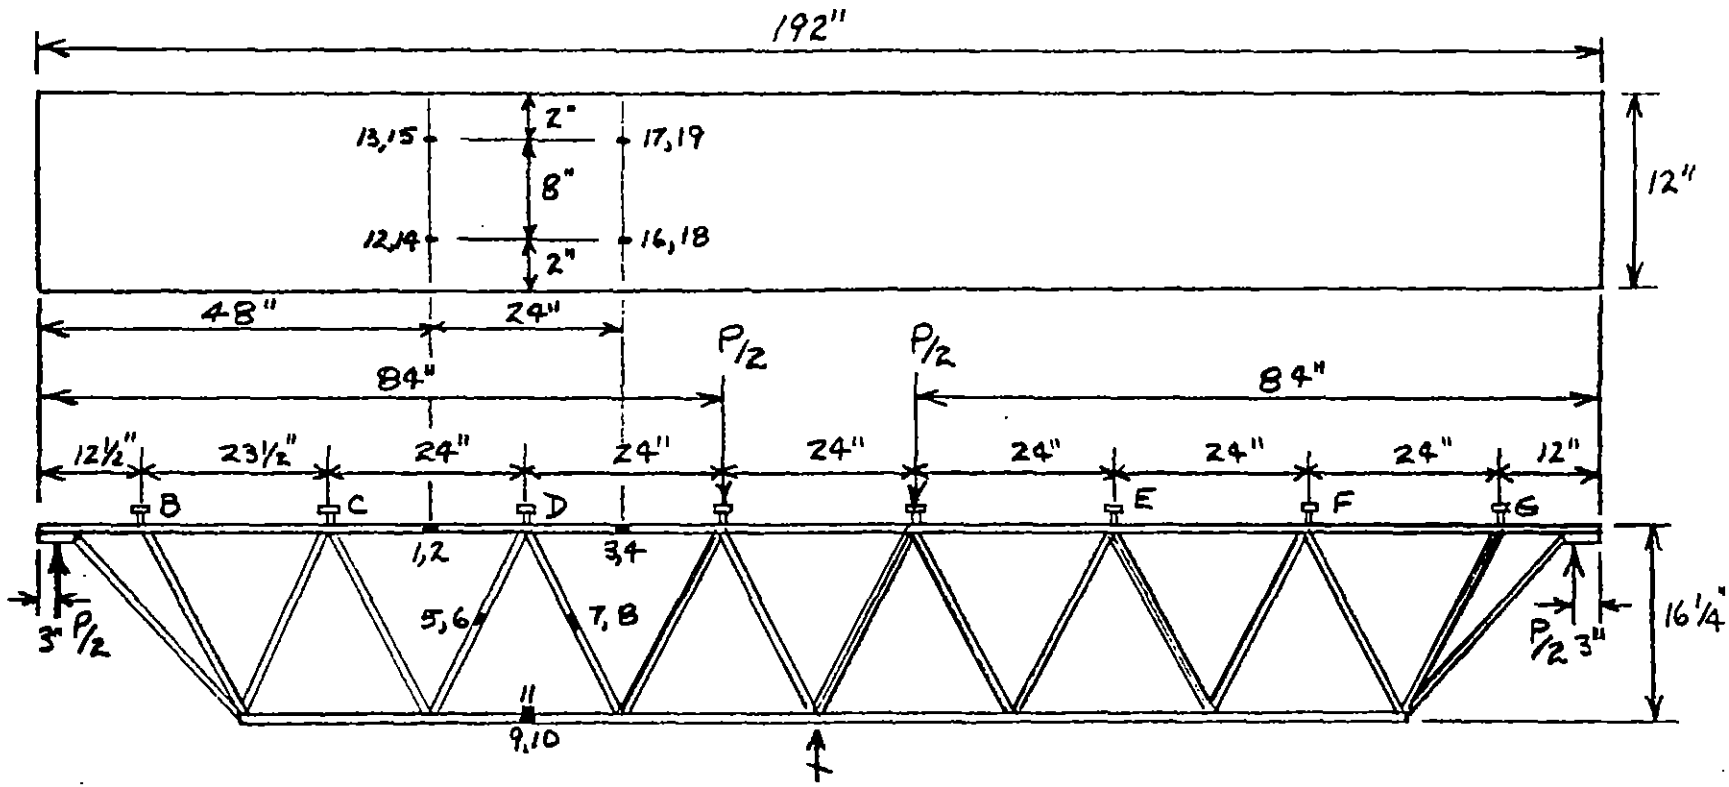
FIG 3m Test Joist B5

4.2.5 B5 - The load was applied in increments as observations were made. Cracks developed in the slab at the first shear connector in each span. After another two load increments cracks had also developed at the load point and the previous two had extended further into the slab. With additional loading it became a little difficult to hold the load steady. As the load was increasing the second weld connection of the right span between the web member and bottom chord fractured.

The failure of this beam was a result of the weld failure of the web member to the tension chord.

B5 - failure of a weld between the web and tension chord.

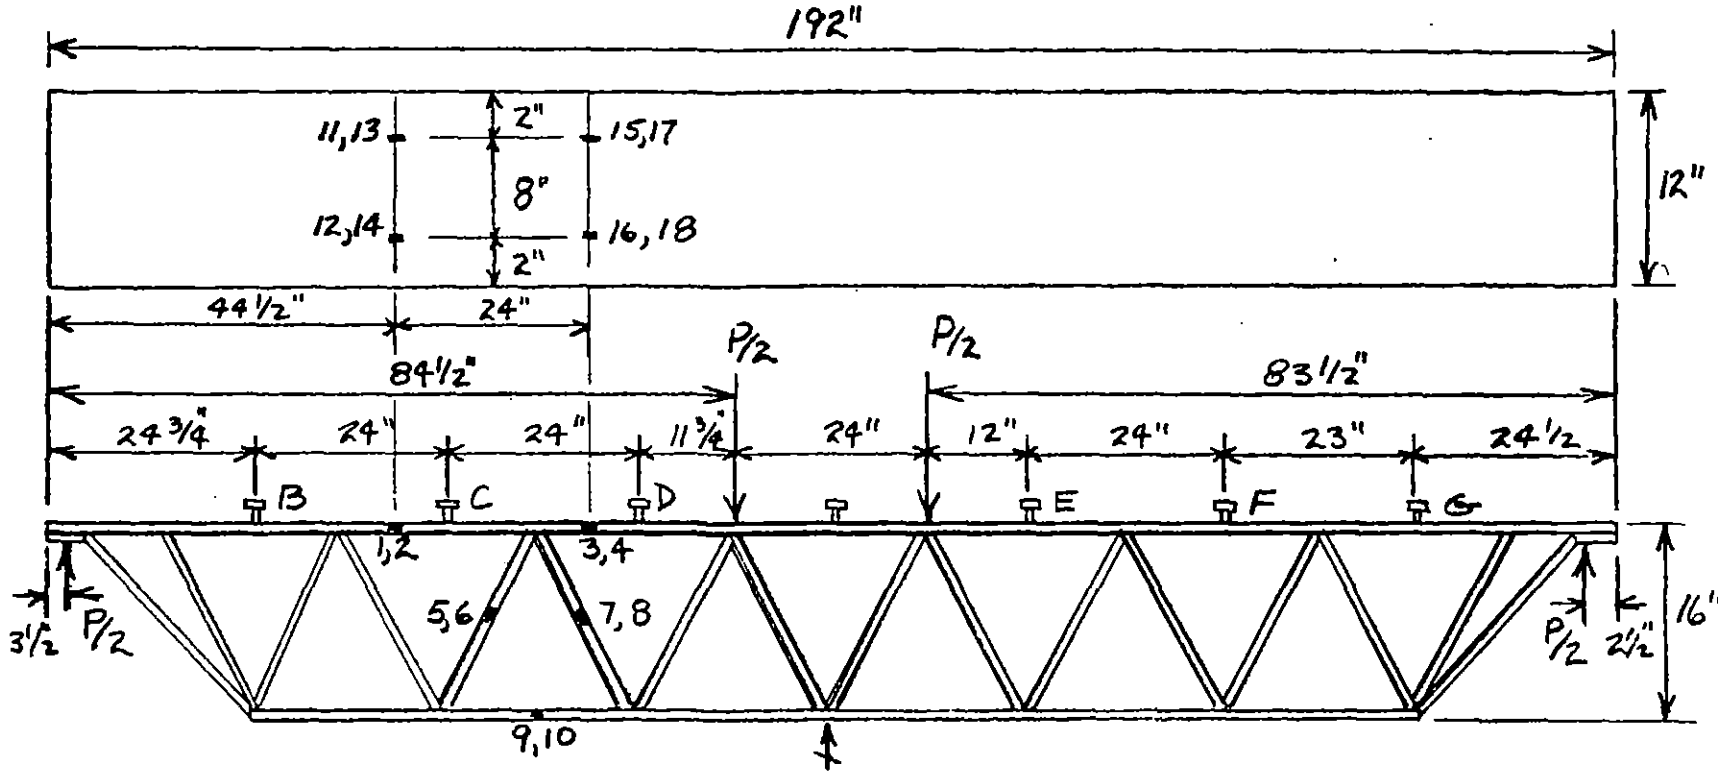
FIG 3n Test Joist B6

4.2.6 _B6 - After several load increments a crack appeared at the first shear connector of the right span. With additional loading the compression chord began to separate from the slab and cracks appeared at the third shear connector in each span. After additional loading a crack appeared at the left load point. The next loading resulted in the fracture of a weld between web and the tension chord. The beam was unloaded and the weld repaired.

The beam was incrementally loaded to its previous value and the test continued. Shortly thereafter it appeared as if the tension chord had yielded as large deflections with small load increases were obtained. As more load was applied it was noticed that the concrete slab was being bent in the reverse direction as tension cracks were appearing on the top of the slab. As more deflection occurred the slab split just to the left of the left load point.

Failure was attributed to yielding of the tension chord followed by the splitting of the concrete.

B6 - yielding of the tension chord, splitting of the concrete.

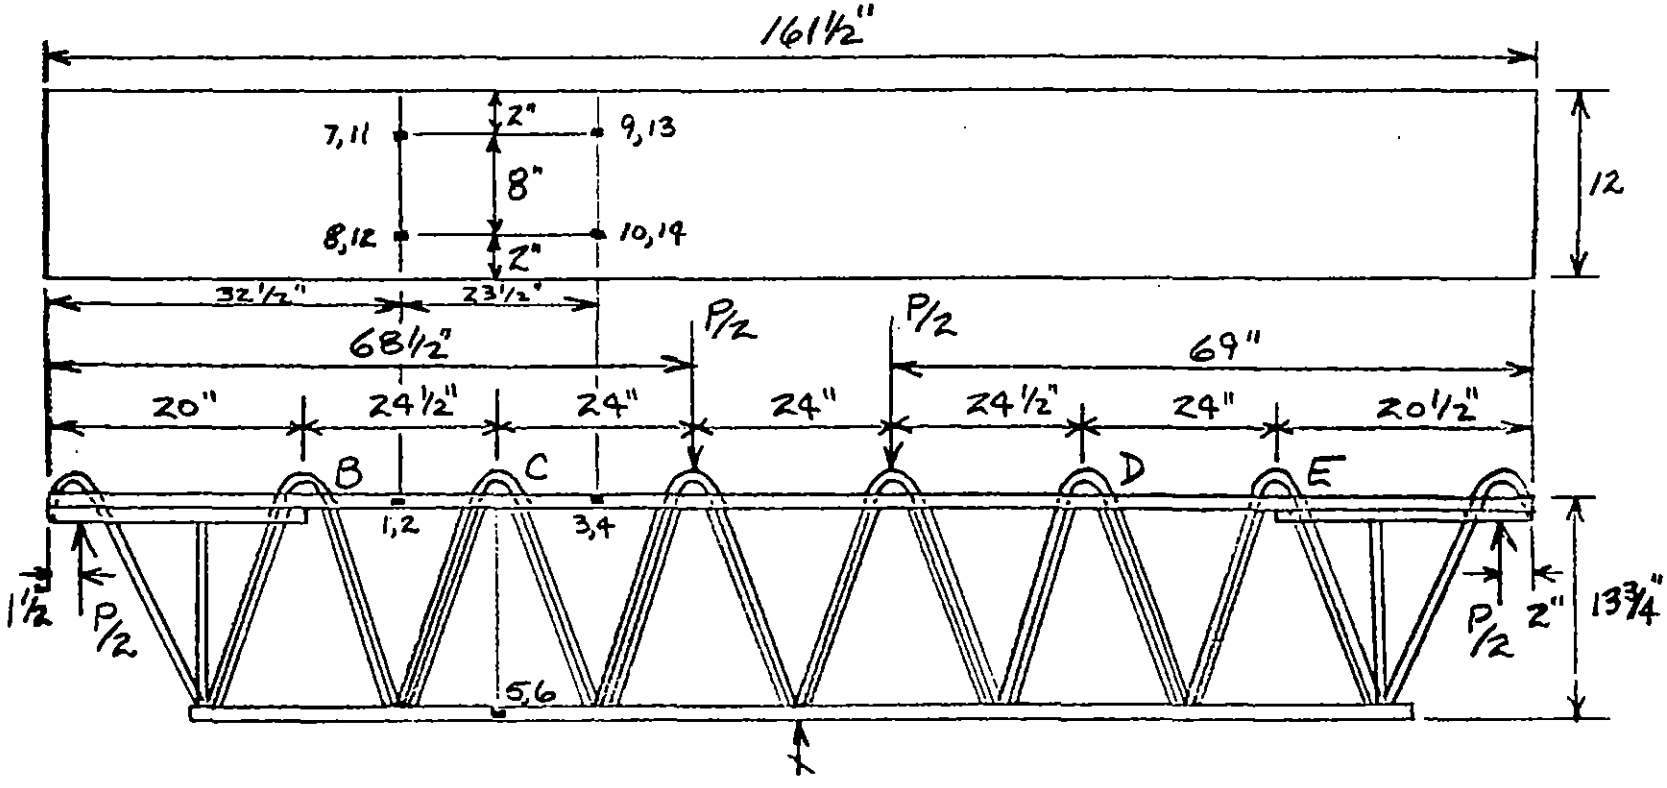
FIG 30 Test Joist B7

4.2.7 _B7 - The load was applied in increments as observations were made. Cracks appeared around the third extended web of the left span and the compression chord separated from the slab between this point and the left load point. As more load was applied the cracks and separation increased. A loud report was heard but no evident damage could be seen. With more loading the one compression member at the third extended web began to separate considerably indicating the weld at this point had fractured. The loading then became difficult to hold steady as the separation and concrete cracks increased. The concrete cracks around the third extended web developed into general crushing. With a loud report the extended web pulled out of the concrete and the compression chord

buckled.

Failure was attributed to crushing of the concrete followed by the buckling of the compression chord.

B7 - crushing of concrete, buckling of the compression chord.
